NASA-DoD Lead-Free Electronics Project

Joint Test Report - Final

December 2011

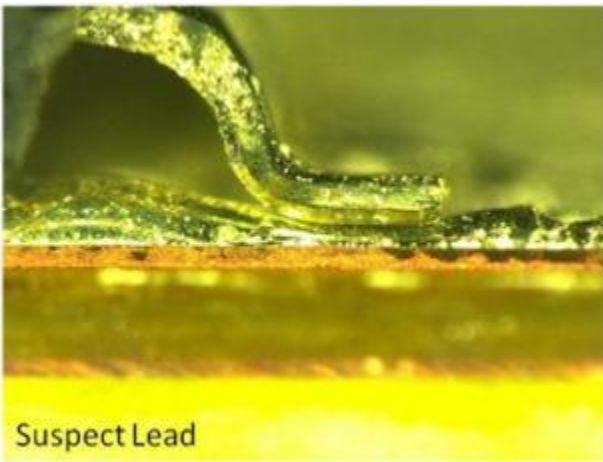
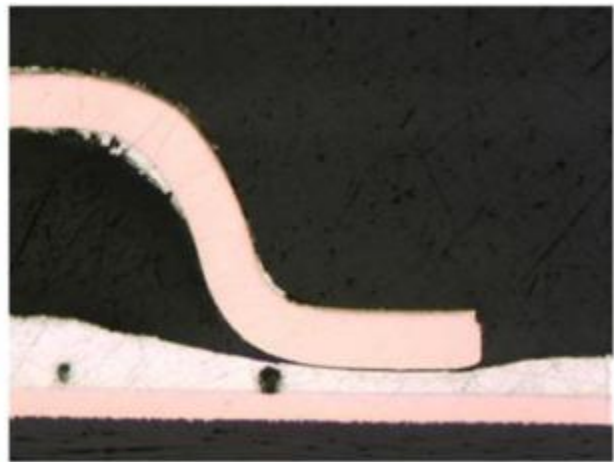
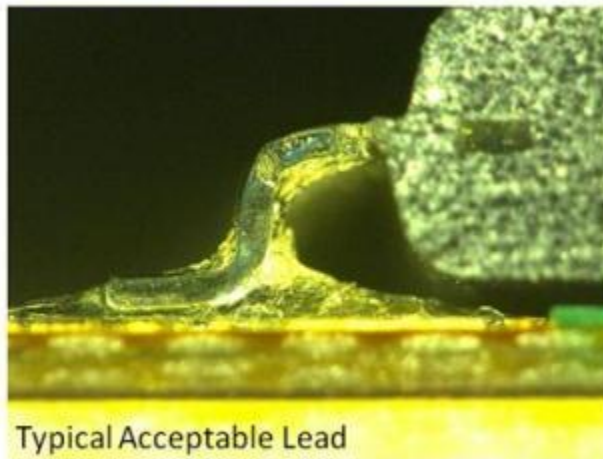
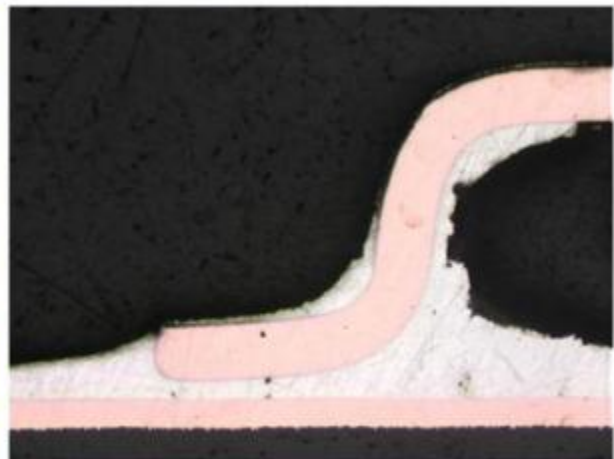
Figure 113 - TV183 U 41; Cross-Sectional Micrographs

Figure 113 shows cross-sectional micrographs of component leads comparing suspect lead to a typical acceptable lead.

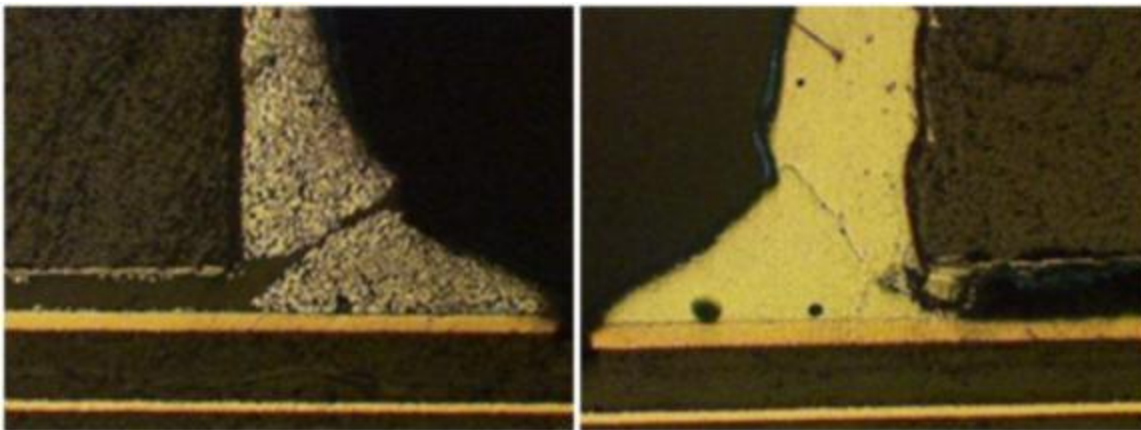
- The cracks in the solder joints initiated under the components and traversed at a 45° angle thru the solder fillets. The crack formation and location are in agreement with industry published data of CLCC failure modes (2), (3).
- The solder joint geometries and wetting angles were acceptable and met industry workmanship criteria
- The solder joint microstructures were reasonably homogenous with no segregation regions observed in the mixed metallurgy cases

Figure 118 - CLCC-20 Solder Joints; Left - Board 5, Component U14, SnPb/SnPb, Failed @ 2625 Cycles; Right - Board 43, Component U14, SAC305/SAC305, Failed @ 513 Cycles

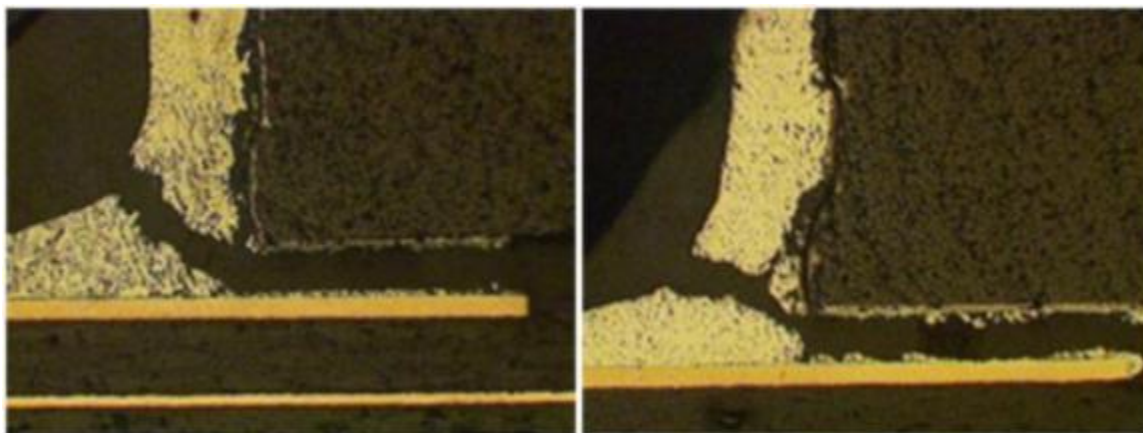
Figure 119 - CLCC-20 Solder Joints; Left - Board 164, Component U14, SAC305/SnPb, Failed @ 1248 Cycles; Right - Board 126, Component U14, SnPb/SAC305, Failed @ 2064 Cycles

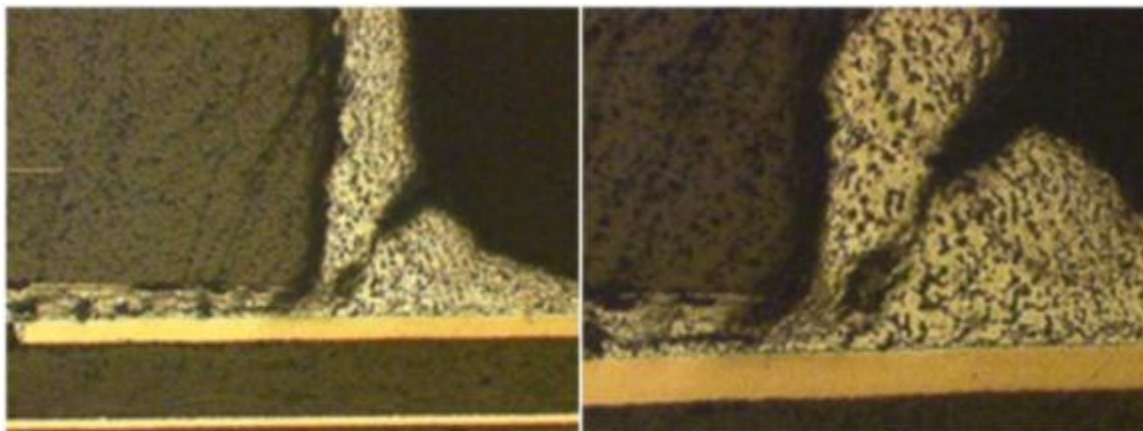
Figure 120 - CLCC-20 Solder Joints, Board 103, Component U22, SN100C/SnPb, Failed @ 828 Cycles

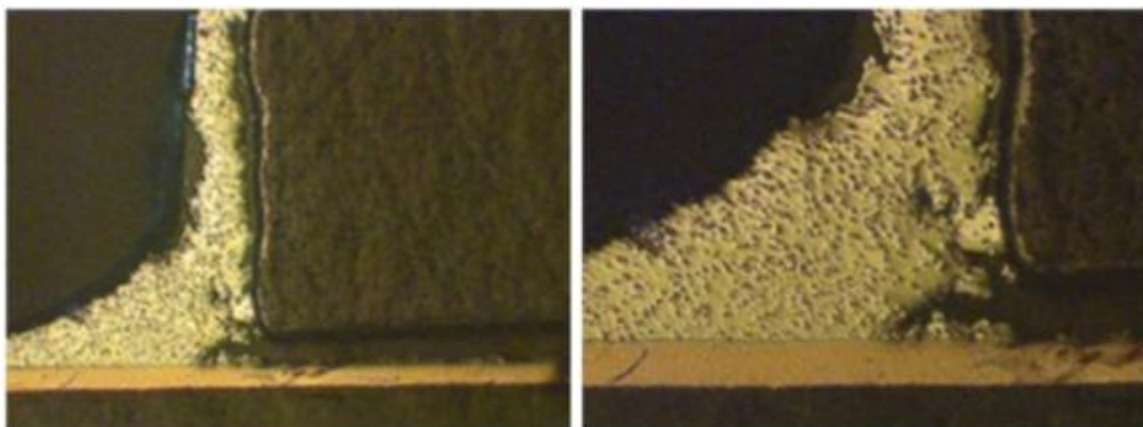
Figure 121 - CLCC-20 Solder Joints, Board 104, Component U14, SN100C/SAC305, Failed @ 304 Cycles

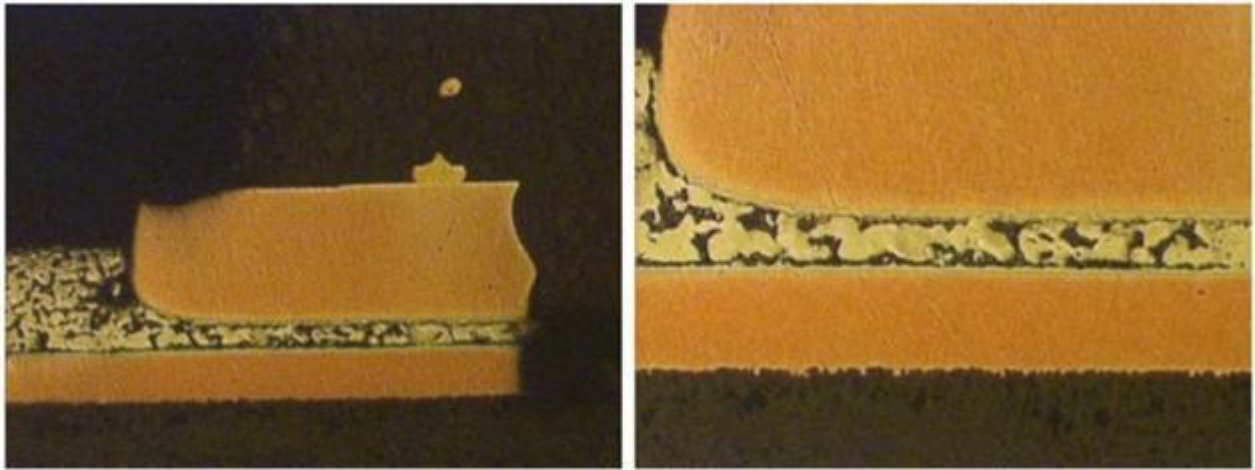
- The cracks in the solder joints initiated in the bottom terminated pads and traversed towards the lead toe. The crack formation and location are in agreement with industry published data of QFN failure modes (4), (5).
- The solder joint geometries and wetting angles were acceptable and met industry workmanship criteria. The ground pad on the QFN-20 components achieved 50% minimum solder coverage and no cracking was observed in that solder joint.
- The solder joint microstructures were homogenous with no segregation regions observed. The solder paste alloy completely dominated the solder joint microstructure regardless of the component surface finish.
- The Stencil Quik reworked solder joints were significantly thicker than the traditionally reworked solder joints (Figure 130 and Figure 131).

Figure 124 - QFN-20 Solder Joints, Board 6, Component U27, SnPb/Sn Dipped, Did Not Fail (DNF)

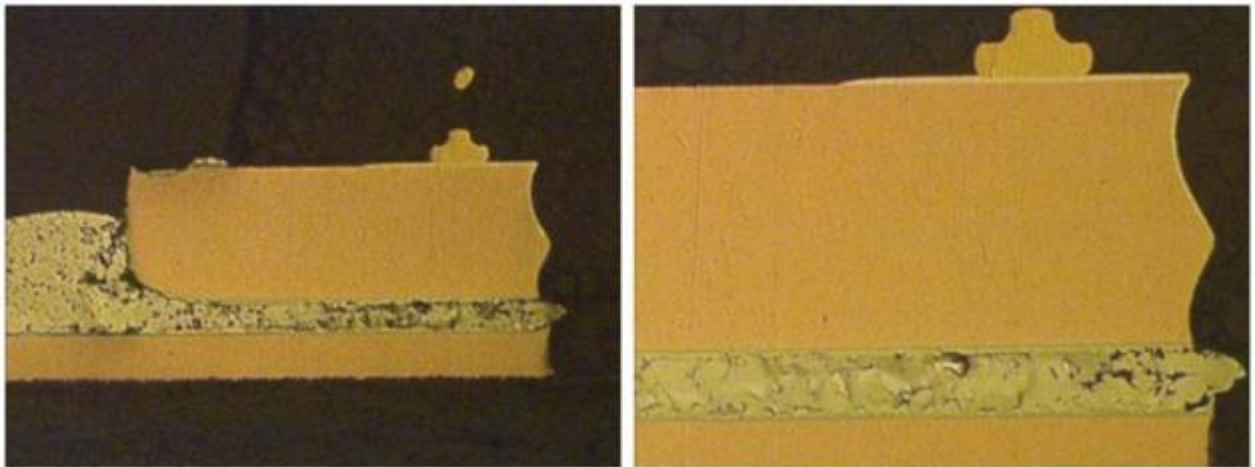
Figure 125 - QFN-20 Solder Joints, Board 42, Component U54, SAC305/Sn, DNF

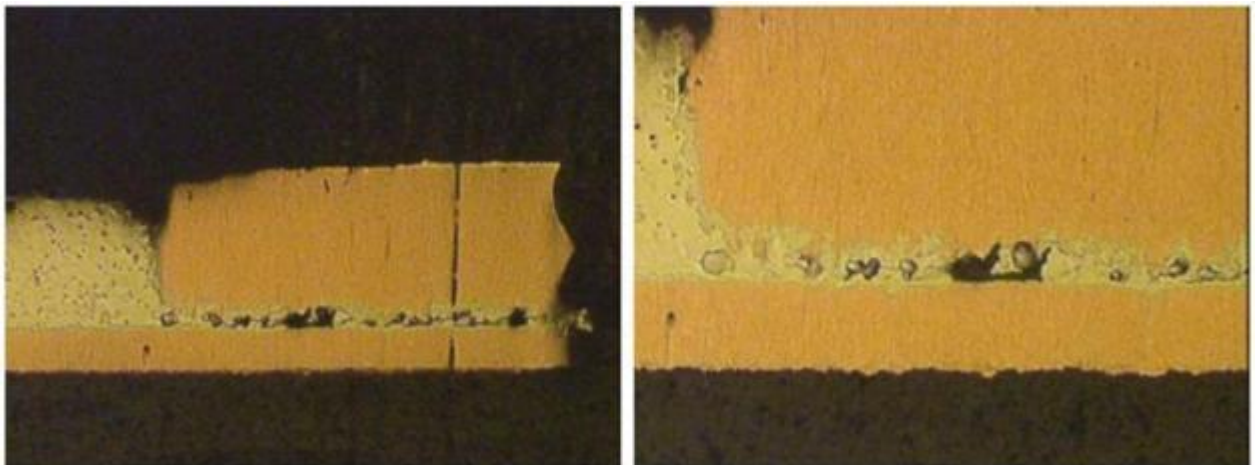
Figure 126 - QFN-20 Solder Joints, Board 104, Component U27, SN100C/Sn, DNF

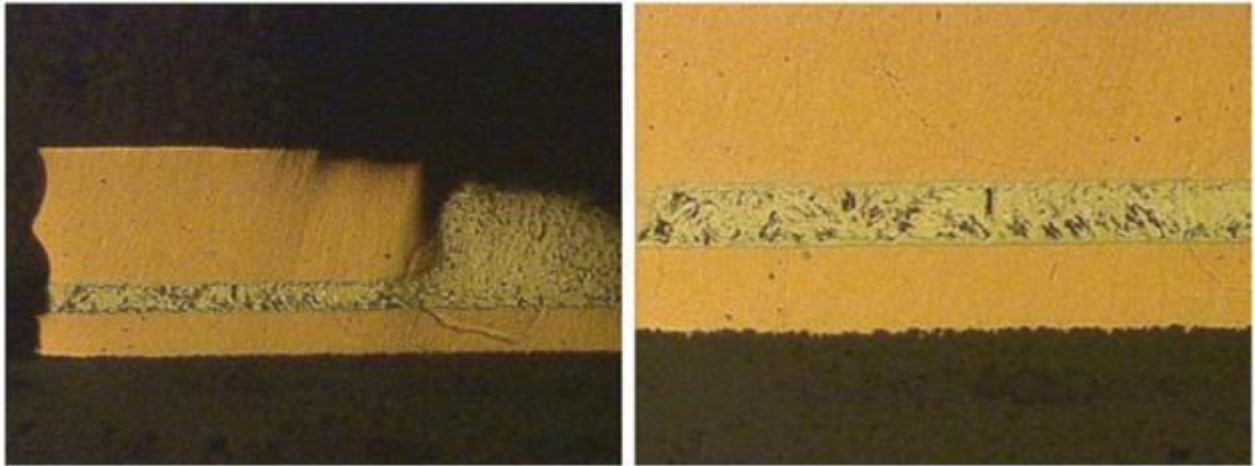
Figure 127 - QFN-20 Solder Joints, Board 167, Component U15, SAC305/SnPb, DNF

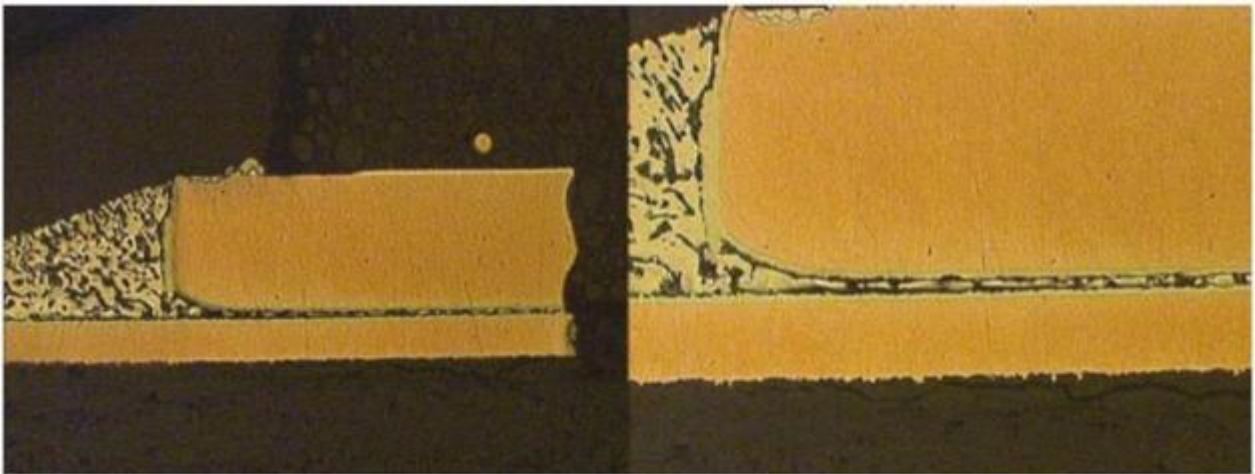
Figure 128 - QFN-20 Solder Joints, Board 107, Component U28, SN100C/Sn, Reworked with SnPb Paste, 1 Rework Failed @ 277 Cycles

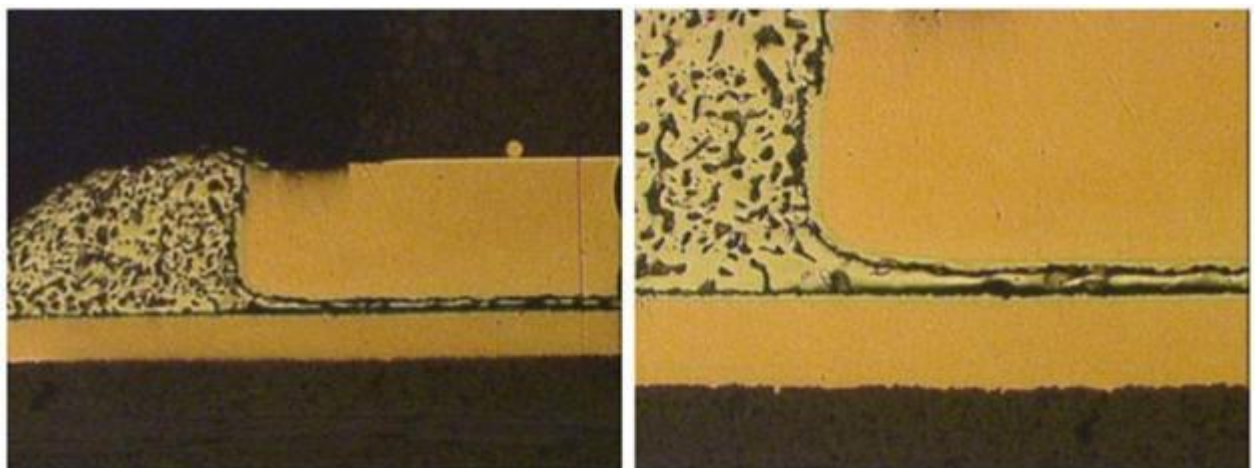
Figure 129 - QFN-20 Solder Joints, Board 108, Component U28, SN100C/Sn, Reworked with SnPb Paste, 2 Reworks, DNF

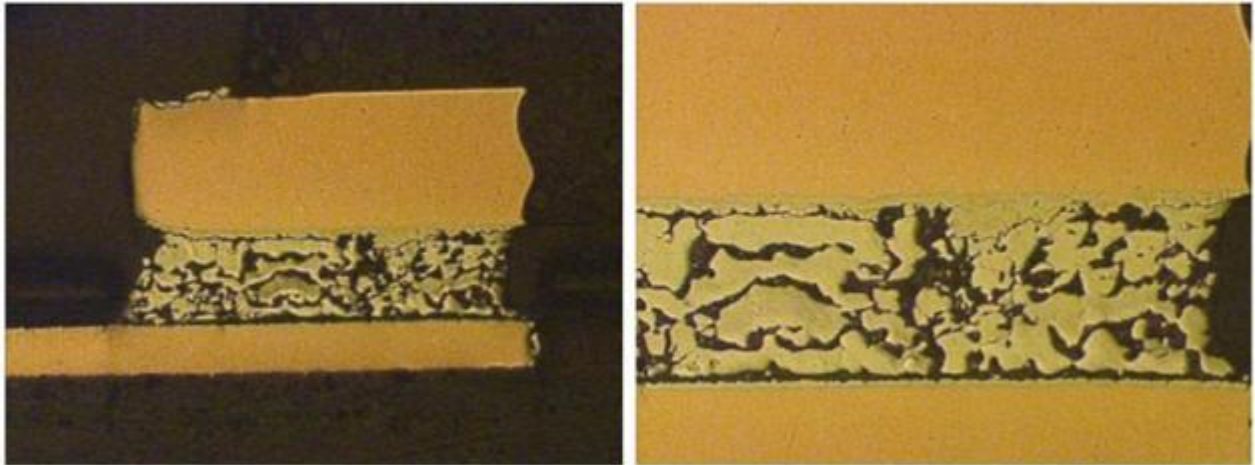
Figure 130 - QFN-20 Solder Joints, Board 109, Component U28, SN100C/Sn, Reworked with Stencil Quik, 1 Rework, DNF

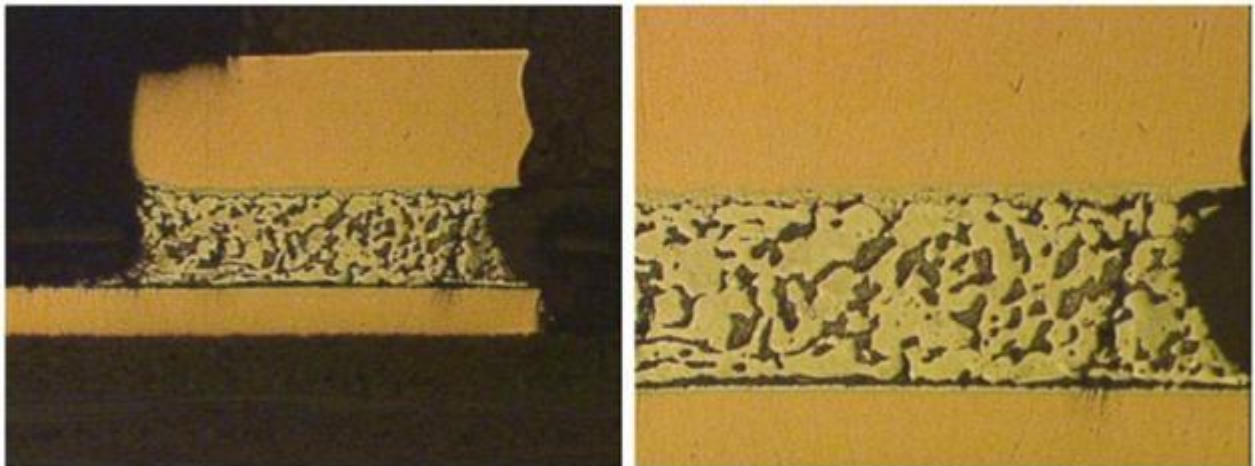
Figure 131 - QFN-20 Solder Joints, Board 47, Component U15, SAC305/Sn, Reworked with Stencil Quik, 1 Rework, Failed @ 3660 Cycles

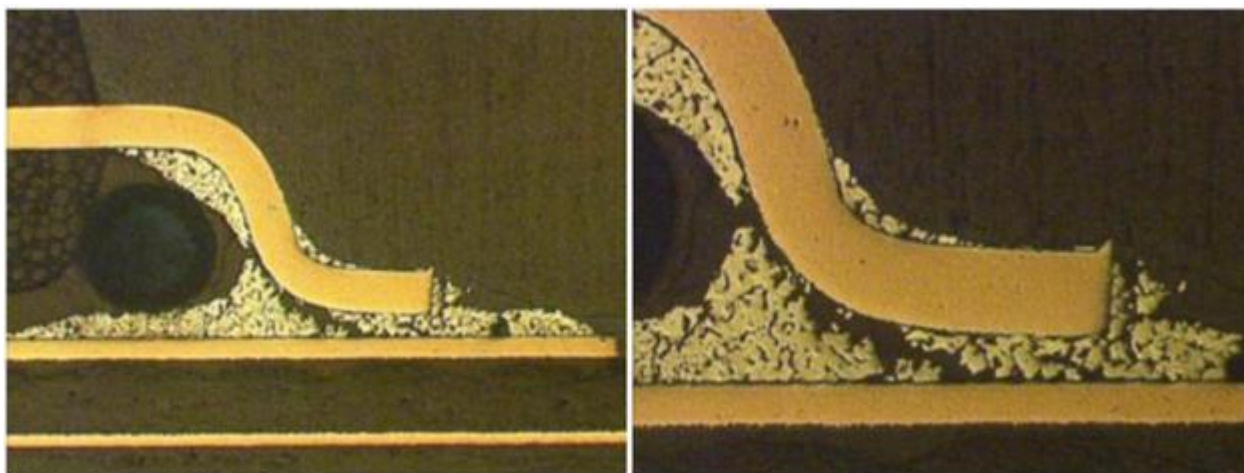
- The cracks in the solder joints initiated in the heel fillet region and traversed under the foot towards the lead toe. The crack formation and location are in agreement with industry knowledge of QFP failure modes (1).
- The solder joint geometries and wetting angles were acceptable and met industry workmanship criteria. There were a number of instances where the solder did flow into the upper lead bend region which is acceptable per industry standards.
- The solder joint microstructures were reasonably homogenous with no segregation regions observed in the mixed metallurgy cases.

Figure 135 - TQFP-144 Solder Joints, Board 9, Component U48, SnPb/SnPb Dipped, Failed @ 2648 Cycles

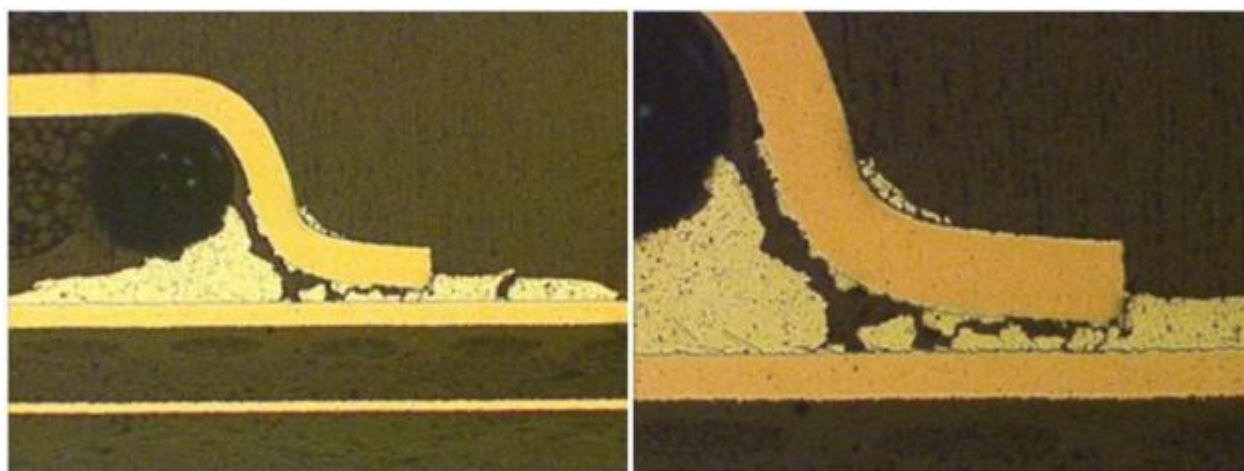
Figure 136 - TQFP-144 Solder Joints, Board 41, Component U20, SAC305/SnPb Dipped, Failed @ 3541 Cycles

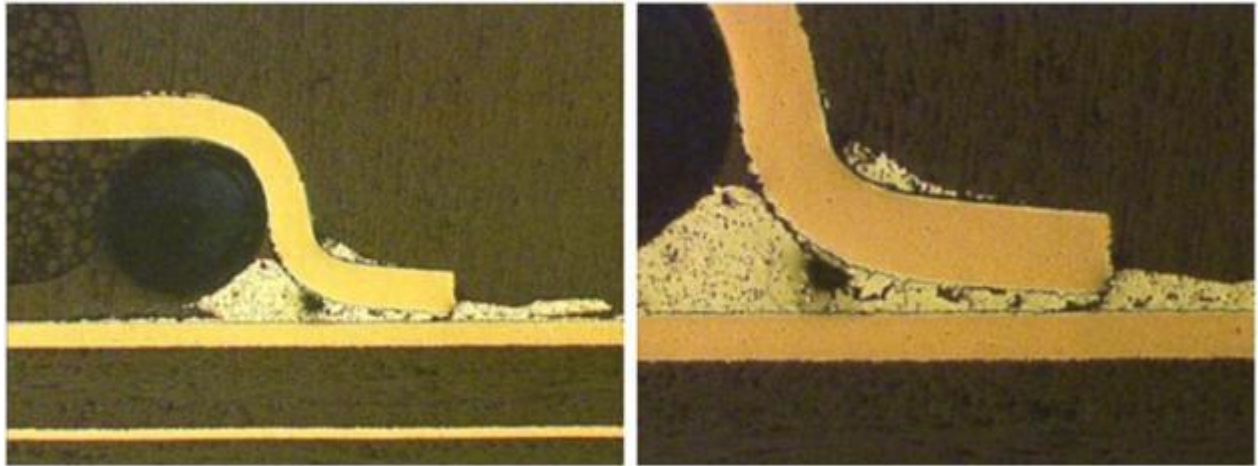
Figure 137 - TQFP-144 Solder Joints, Board 106, Component U20, SN100C/SnPb Dipped, Failed @ 3258 Cycles

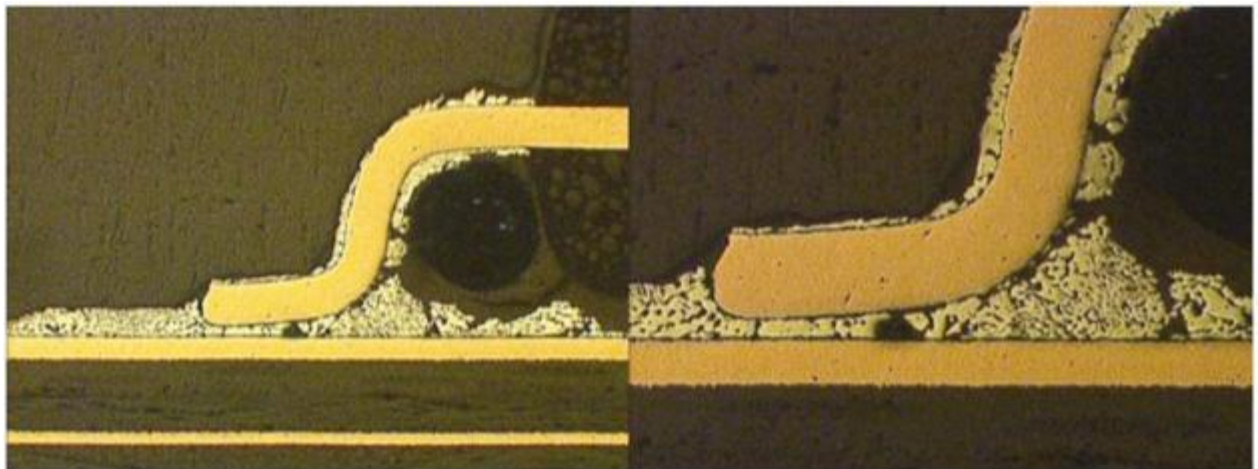
Figure 138 - TQFP-144 Solder Joints, Board 9, Component U1, SnPb/Sn, Failed @ 1 Cycle

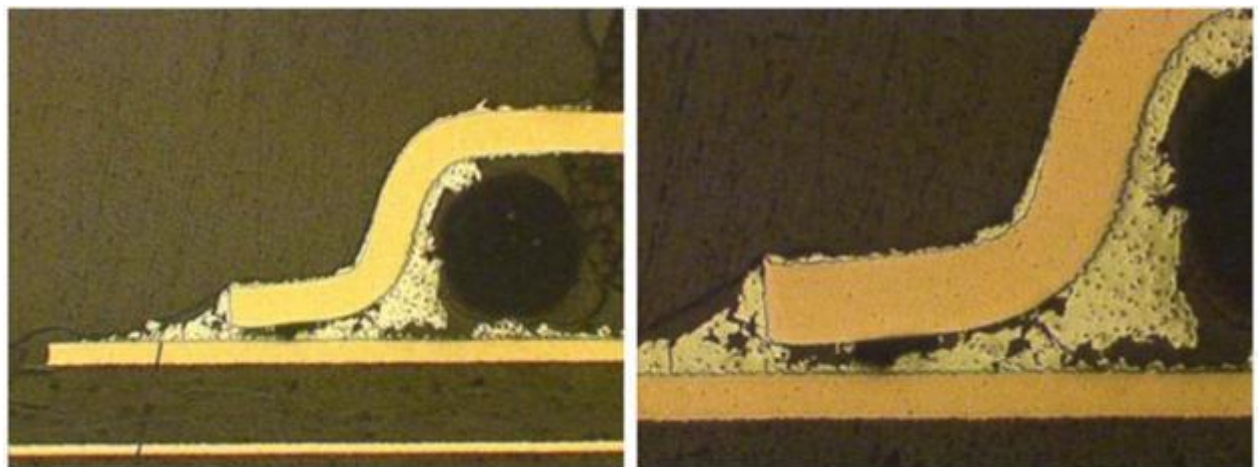
Figure 139 - TQFP-144 Solder Joints, Board 49, Component U57, SAC305/Sn, Failed @ 1430 Cycles

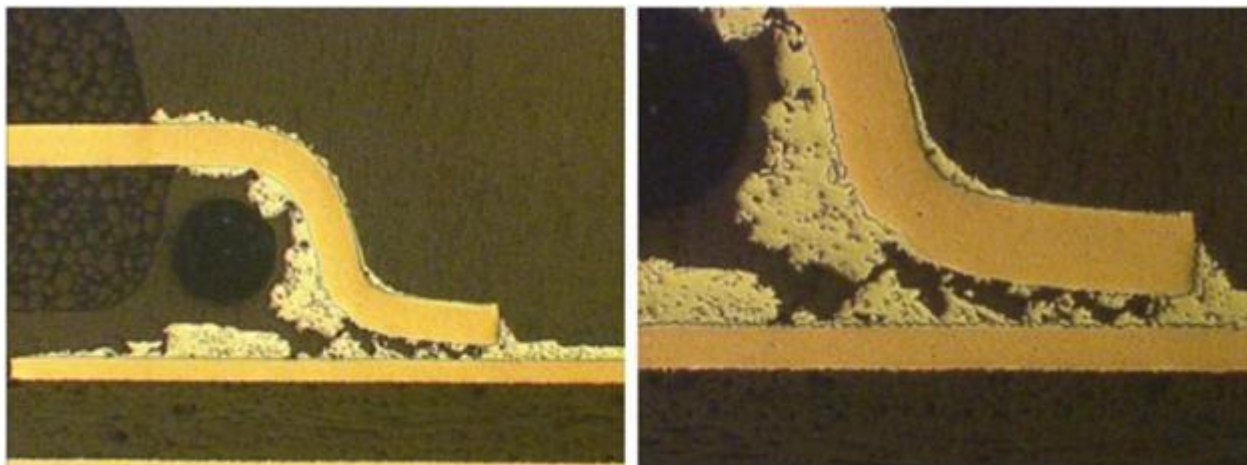
Figure 140 - TQFP-144 Solder Joints, Board 103, Component U48, SN100C/Sn, Failed @ 1712 Cycles

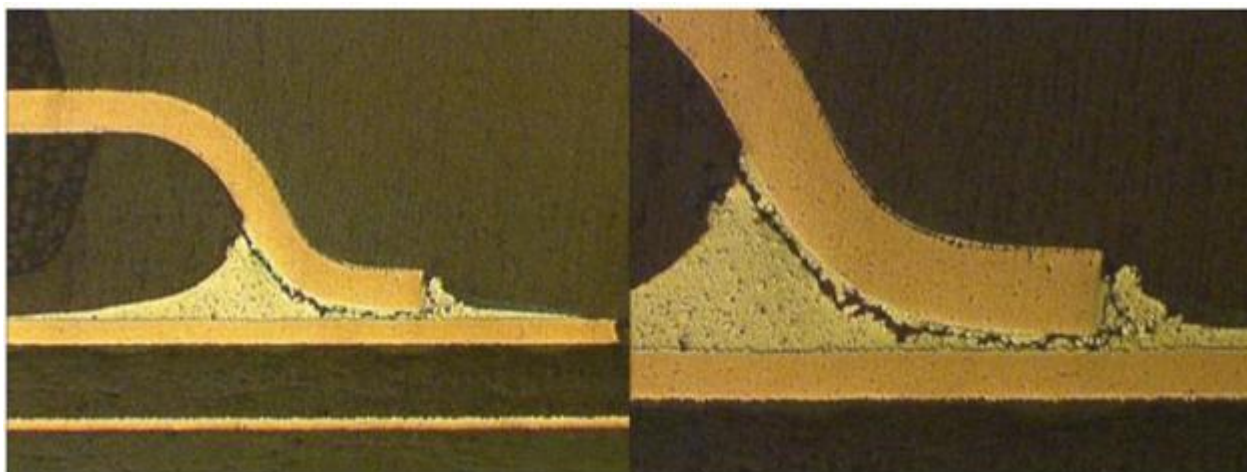
Figure 141 - TQFP-144 Solder Joints, Board 167, Component U57, SAC305/NiPdAu, Failed @ 3478 Cycles

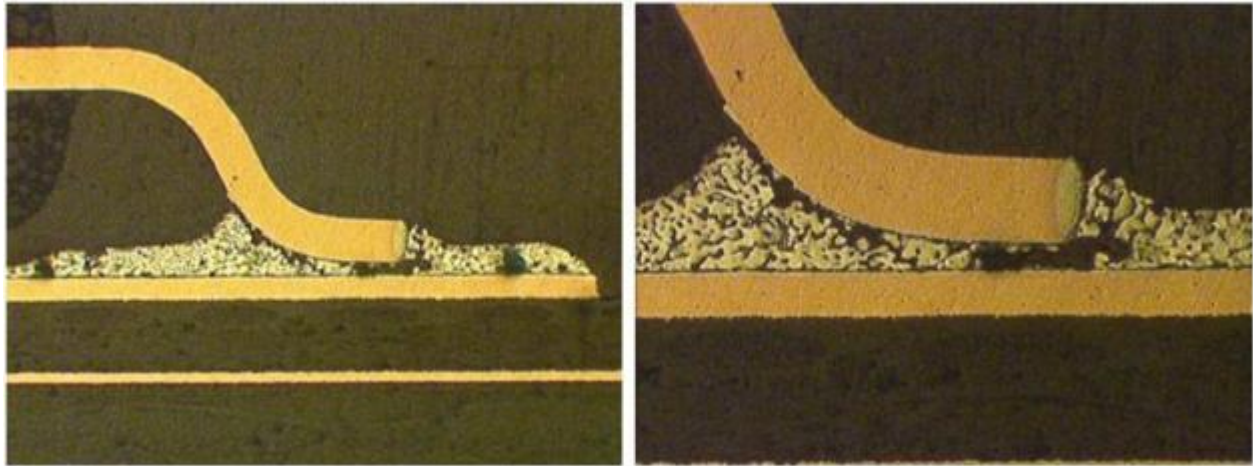
Figure 142 - TQFP-144 Solder Joints, Board 127, Component U3, SnPb/NiPdAu, Failed @ 1744 Cycles

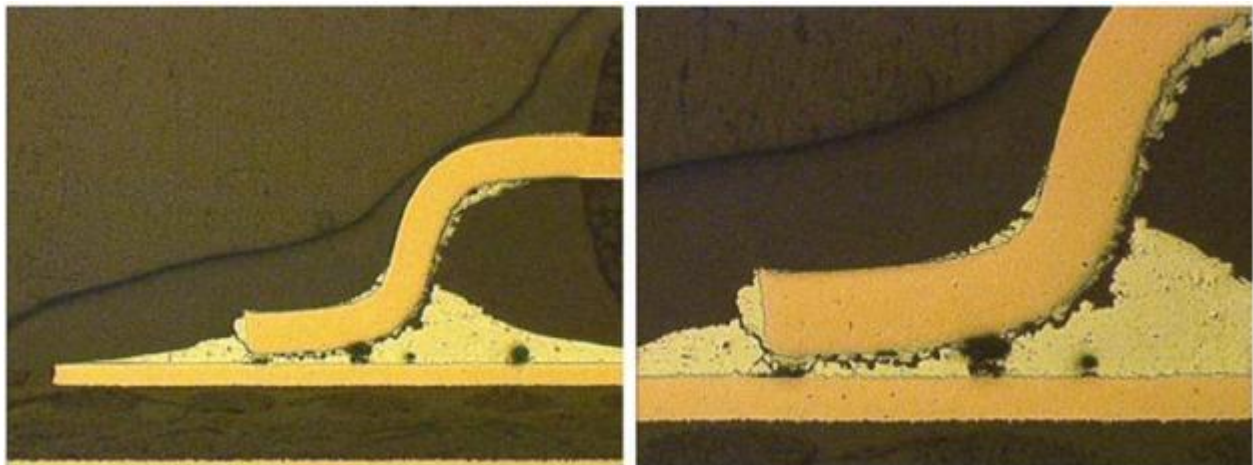
Figure 143 - TQFP-144 Solder Joints, Board 164, Component U7, SAC305/SAC305, Failed @ 2359 Cycles

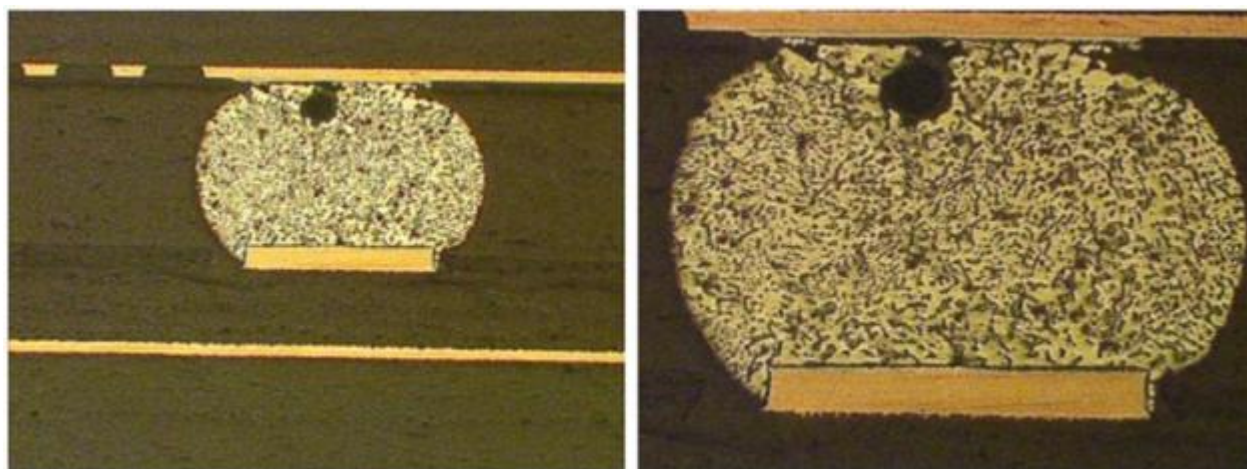
- The cracks in the solder joints initiated at the solder joint/component pad interface. The crack formation and location are in agreement with industry knowledge of PBGA failure modes(6), (7).

- The manufactured test vehicle solder joint microstructures were homogenous with no segregation regions and the solder ball alloy (i.e. SnPb or SAC405) dominated the microstructure as it provided the largest material contribution to the solder joint formation. Some instances of large intermetallic compound (IMC) phases were observed but they typically have minimal interaction with the crack failure path.

Figure 148 - PBGA-225 Solder Joints, Board 8, Component U5, SnPb/SnPb, Failed @ 2431 Cycles

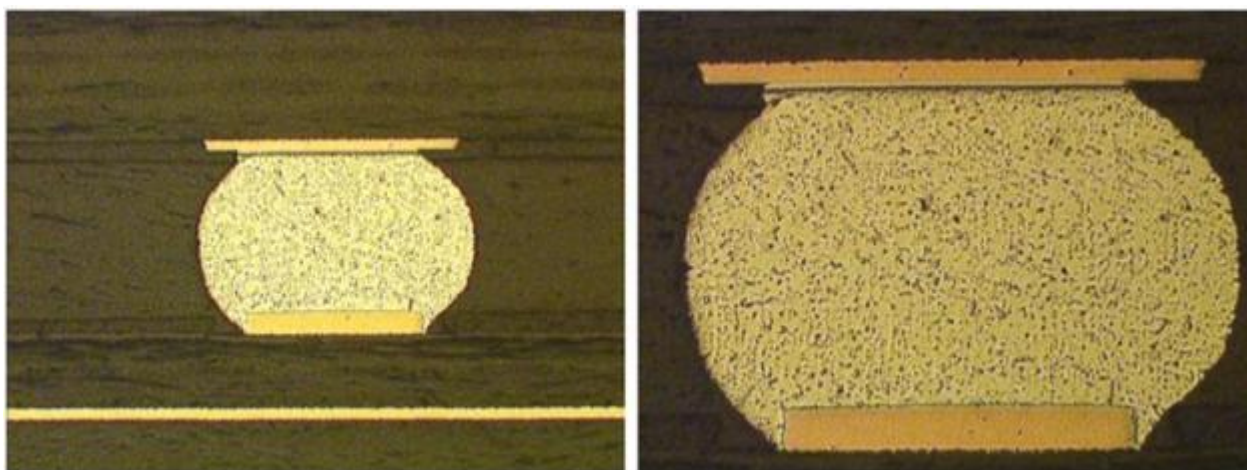
Figure 149 - PBGA-225 Solder Joints, Board 127, Component U5, SnPb/SAC405, DNF

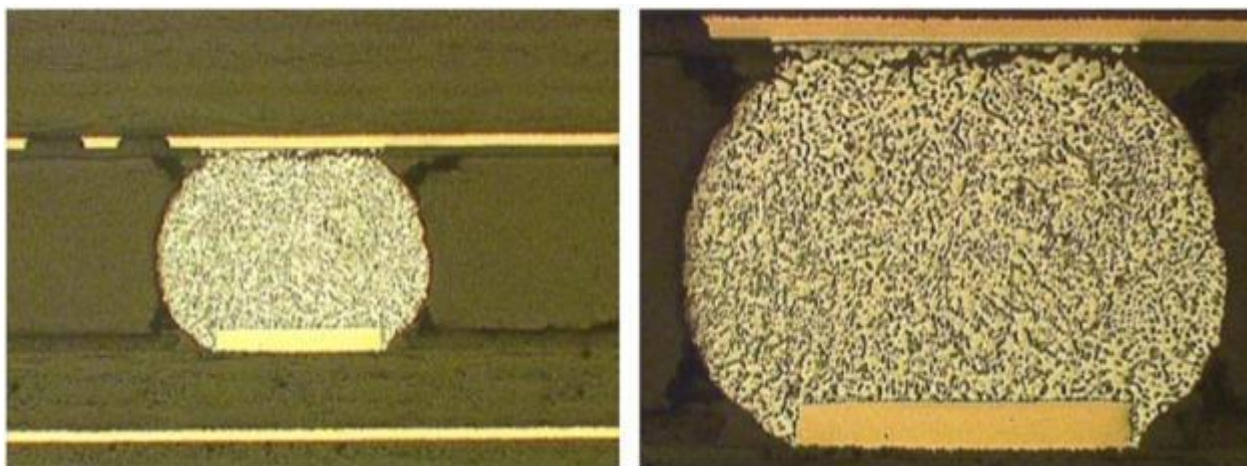
Figure 150 - PBGA-225 Solder Joints, Board 168, Component U5, SAC305/SnPb, Failed @ 1926 Cycles

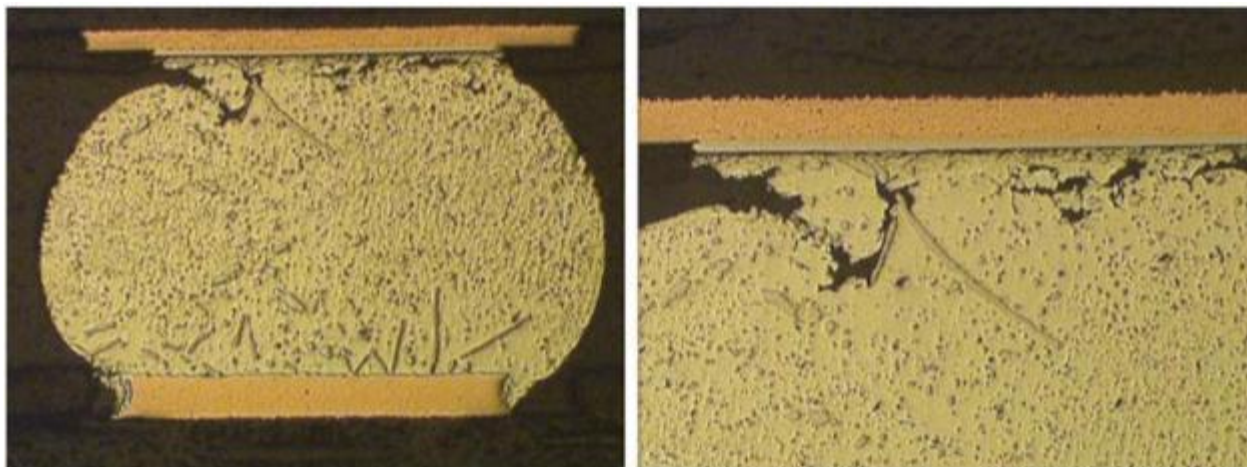
Figure 151 - PBGA-225 Solder Joints, Board 49, Component U6, SAC305/SAC405, Failed @ 2763 Cycles

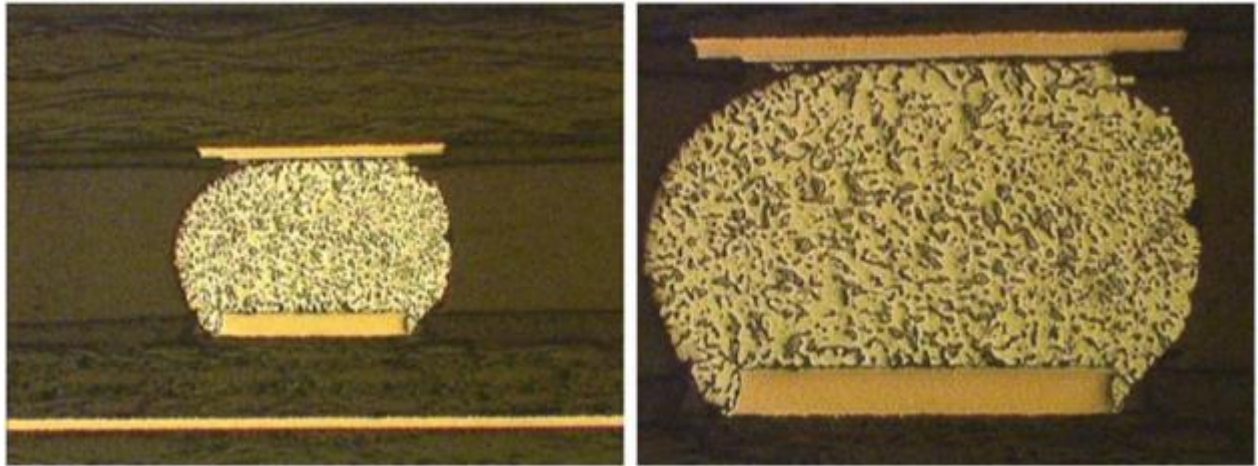
Figure 152 - PBGA-225 Solder Joints, Board 106, Component U55, SN100C/SnPb, Failed @ 1064 Cycles

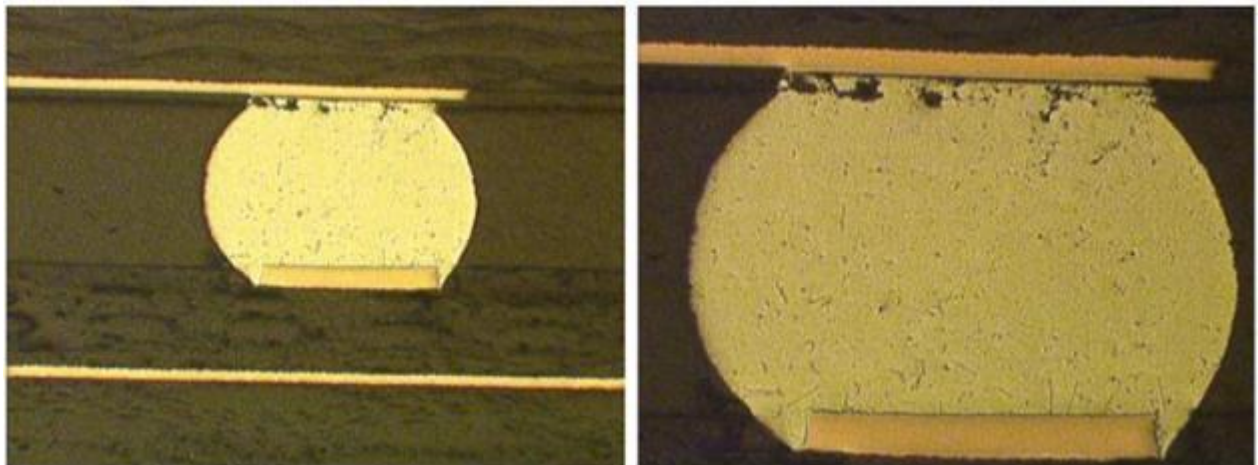
Figure 153 - PBGA-225 Solder Joints, Board 104, Component U21, SN100C/SAC405, Failed @ 3812 Cycles

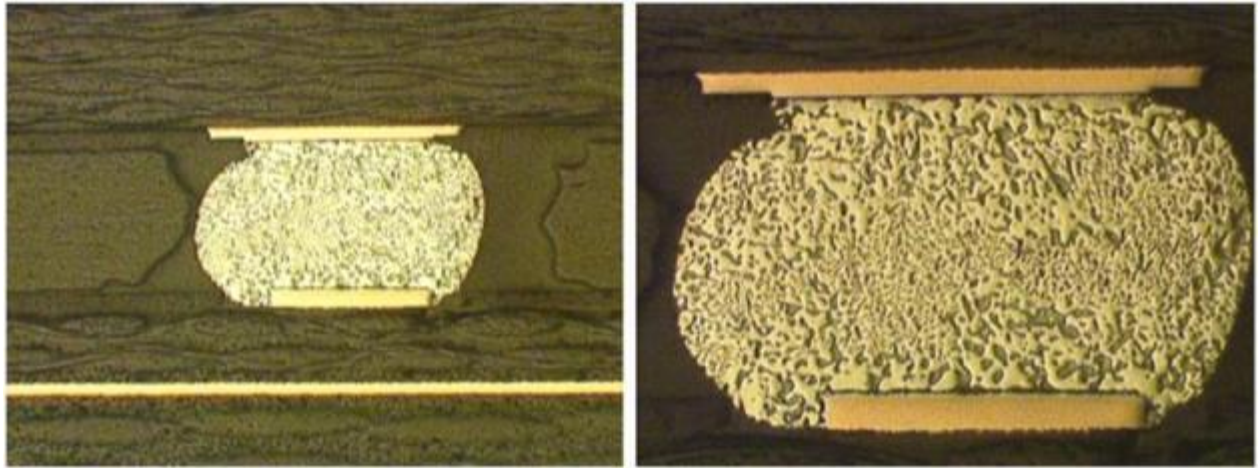
- The reworked test vehicle solder joint microstructures had a number of mixed metallurgy cases where the solder joint was not homogenous. These solder joints tended to fail at the solder joint/test vehicle pad interface with lead (Pb) segregated in the crack interface. This failure mode previously documented in the JCAA/JGPP testing program (8).

Figure 154 - Reworked PBGA-225 Solder Joints, Board 127, Component U56, Initially SnPb/SnPb, 1 rework Flux Only/SnPb, Failed @ 2349 Cycles

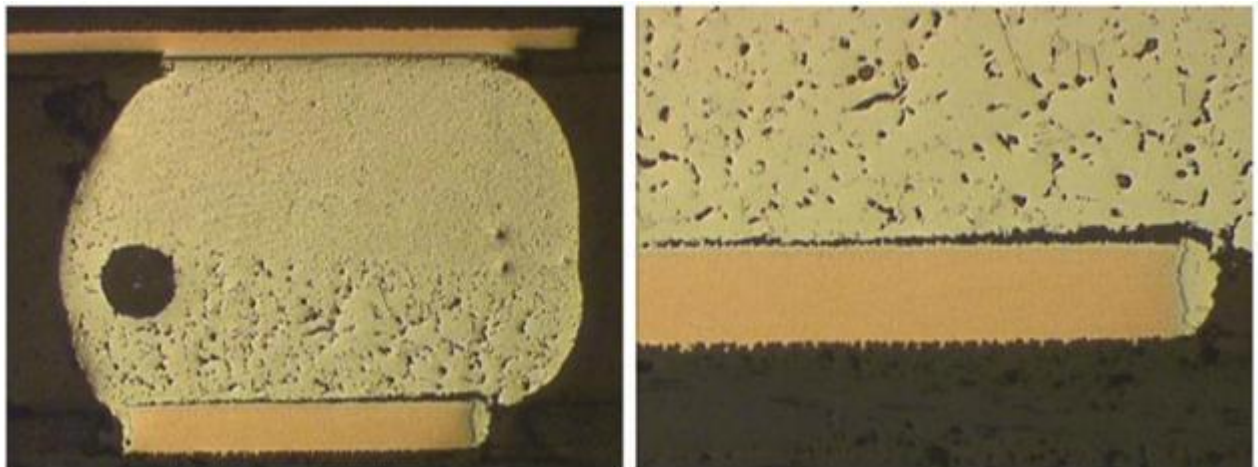
Figure 155 - Reworked PBGA-225 Solder Joints, Board 124, Component U6, Initially SnPb/SnPb, 1 rework SnPb/SAC405, Failed @ 2137 Cycles

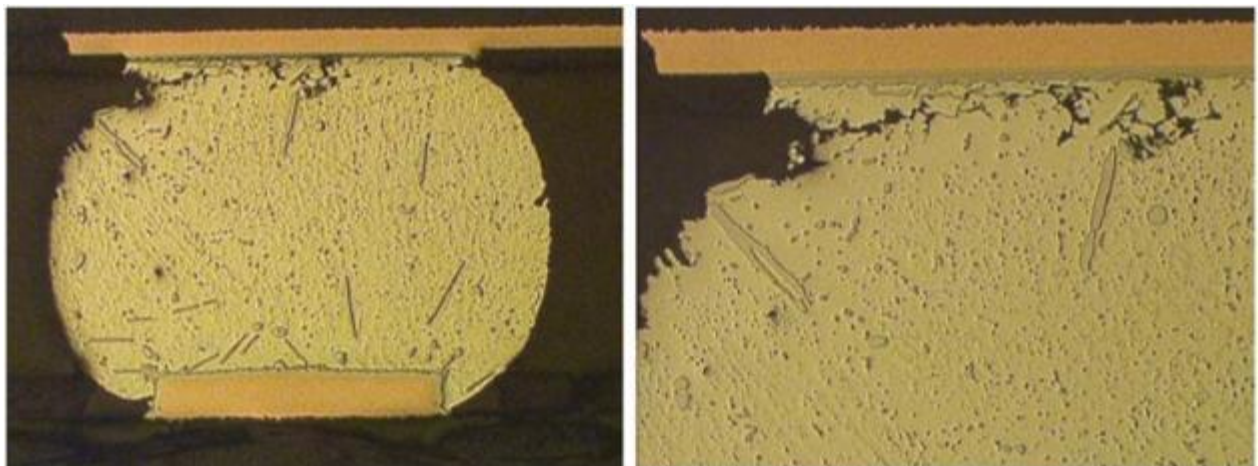
Figure 156 - Reworked PBGA-225 Solder Joints, Board 127, Component U56, Initially SAC305/SAC405, 1 rework Flux Only/SAC405, Failed @ 2349 Cycles

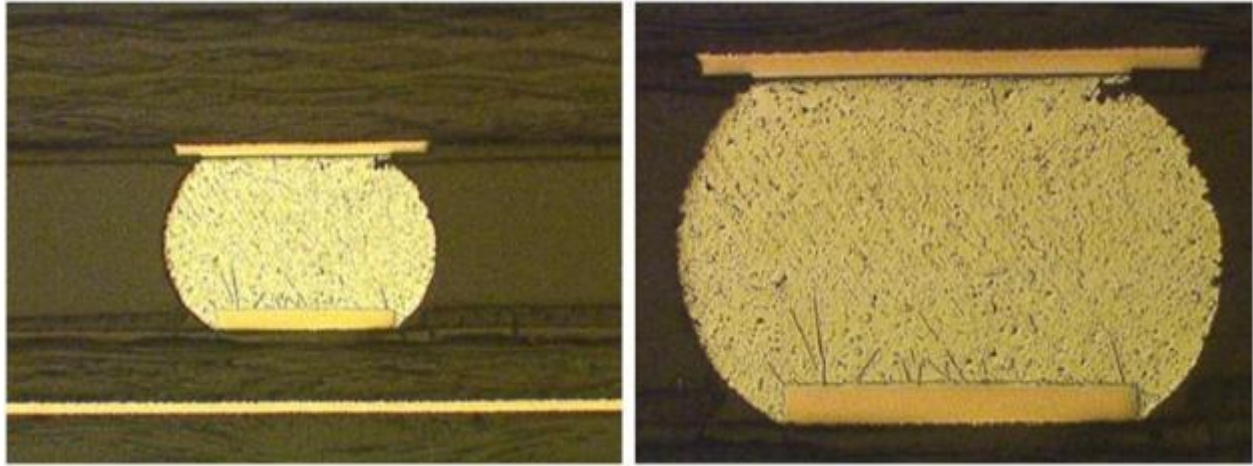
Figure 157 - Reworked PBGA-225 Solder Joints, Board 164, Component U18, Initially SAC305/SAC405, 1 rework SnPb/SAC405, DNF

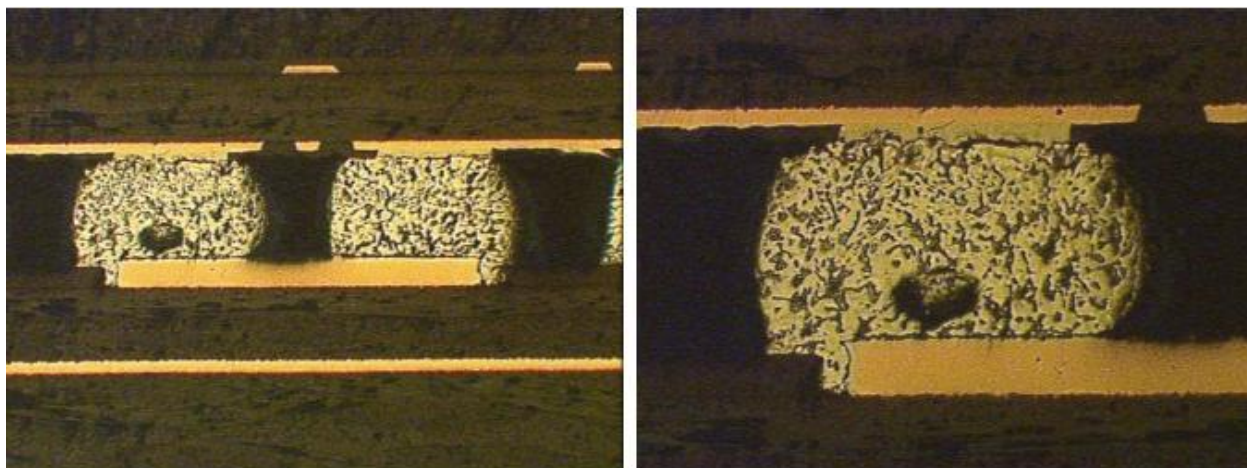
- The cracks in the solder joints were observed to have to failure modes: (1) initiation at the solder joint/component pad interface; (2) significant solder ball deformation with cracks at either solder joint component pad or solder joint/test vehicle pad interface.

Figure 162 - CSP-100 Solder Joints, Board 7, Component U37, SnPb/SnPb, Failed @ 2837 Cycles

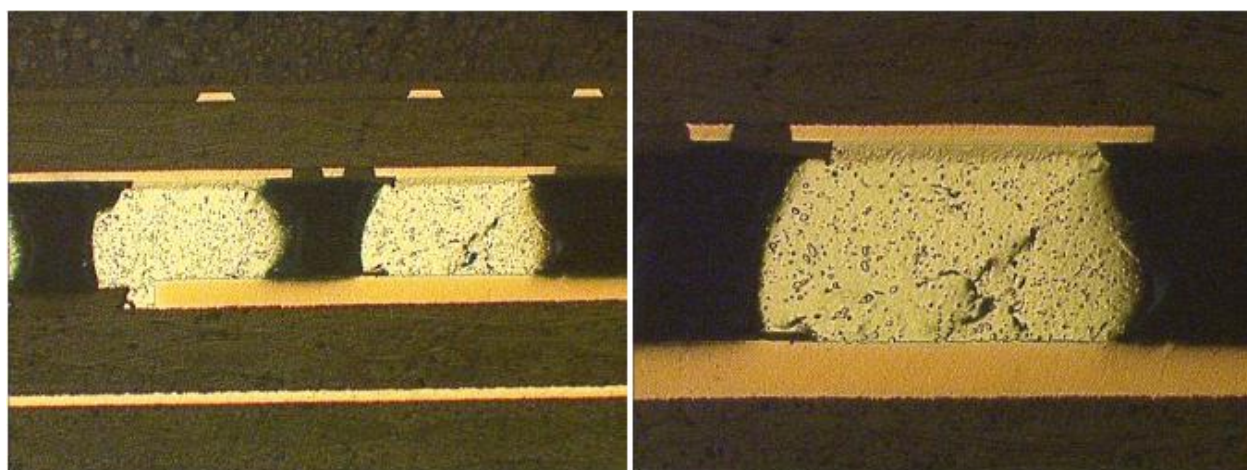
Figure 163 - CSP-100 Solder Joints, Board 124, Component U32, SnPb/SAC105, Failed @ 287 Cycles

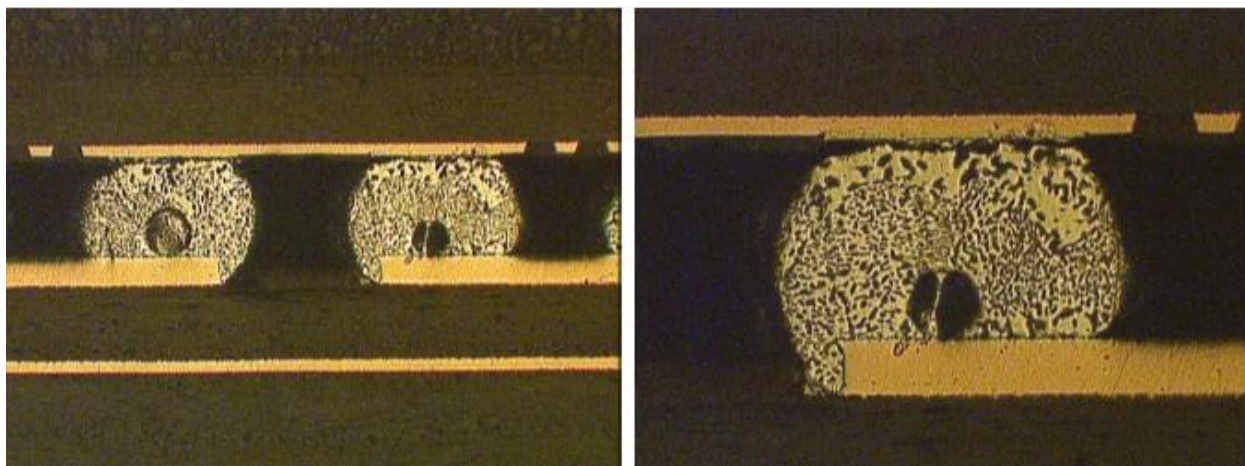
Figure 164 - CSP-100 Solder Joints, Board 166, Component U32, SAC305/SnPb, Failed @ 3417 Cycles
